Home Energy Report

Property Address:
1 Save Energy Road
Anywhere NY

Sample Home

Capital District Home Inspectors and NY Energy Auditors

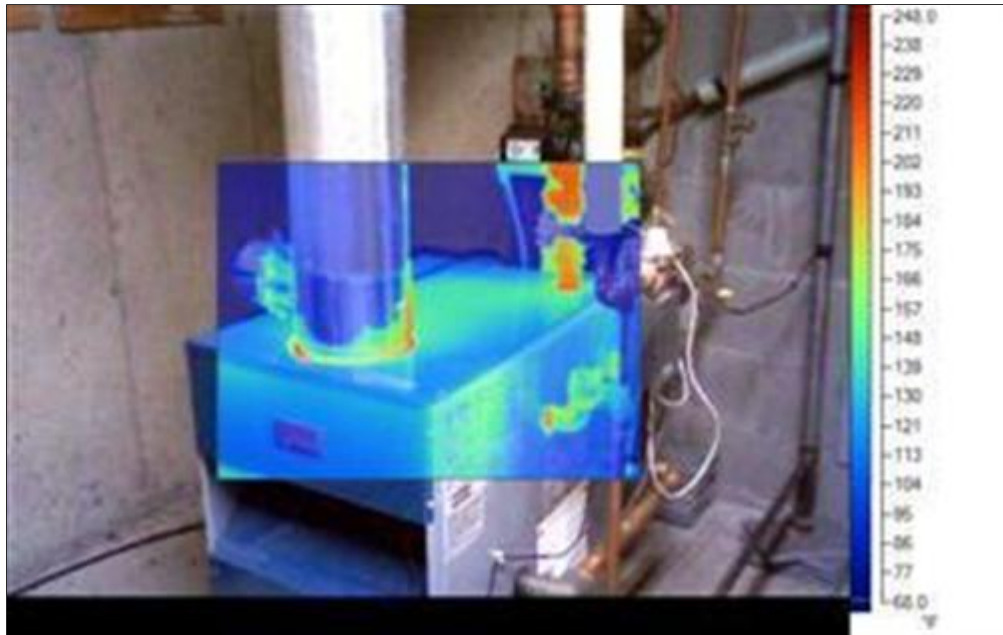
3.0 Picture 1

- 🏠 Thermal image of heat loss at furnace basement location of home. (Picture 1) Recommend evaluation by HVAC expert. Suggest replace furnace over 10 years old and/or less then 60% efficient.

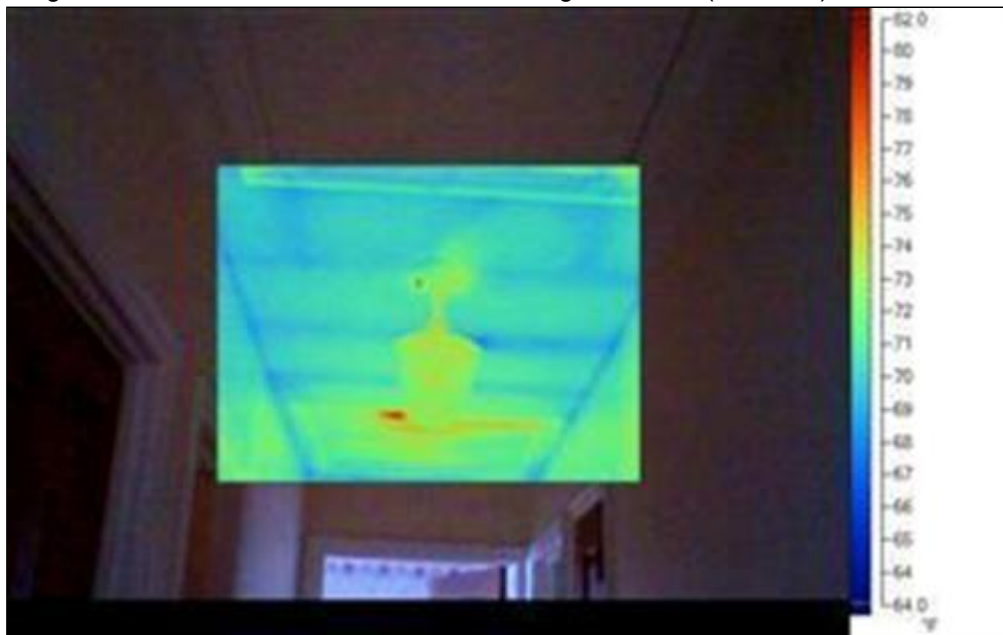
4.0 Picture 1

- 🏠 Second floor ceiling Thermal Camera view of cold air infiltrating from attic. (Picture 1)
